DIGITAL RECORDING AND NON-DESTRUCTIVE TECHNIQUES FOR THE UNDERSTANDING OF STRUCTURAL PERFORMANCE FOR REHABILITATING HISTORIC STRUCTURES AT THE KATHMANDU VALLEY AFTER GORKHA EARTHQUAKE 2015

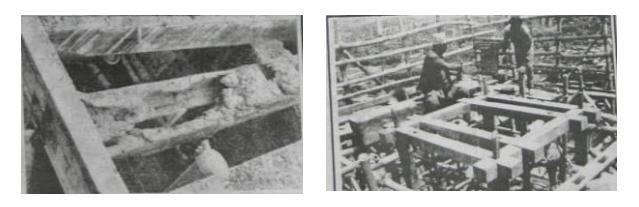
Figure 11. Replacement of decayed timber during 1996 AD restoration work

Major damage is concentrated in upper tier of structure and wall was found to be partially collapsed. The upper tier was recorded to be collapsed in previous 1934 AD earthquake as well and which is reconstructed later on. A major renovation was done during 1996 AD by Bhaktapur Municipality in which majorly roof was repaired wooden post in the upper tier was replaced after founding it was decayed (Figure 11) (Bhaktapur, 1998). This also suggests that there may be the presence of the timber element inside walls in below level as well.

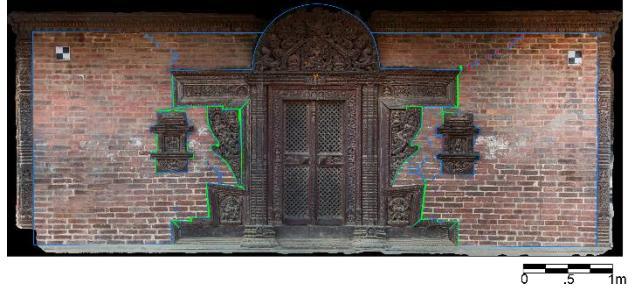
Figure 12. Mapping of existing cracks in structural wall

Existing damage in the structure is digitally recorded using the photogrammetry and laser scanning data. Partially collapsed top wall was found to be torsionally distorted by approximately 3.557° clockwise in respect to the base of the superstructure. However, several shear cracks developed in the doorway on all four-side wall also identified. High-quality orthophotos are generated from the close-range laser scanning and photogrammetric models. These orthophotos were used for mapping existing cracks in the wall (figure 12). Mapping of these cracks will then be introduced in the finite element modeling for assessing the existing performance of structure in future.

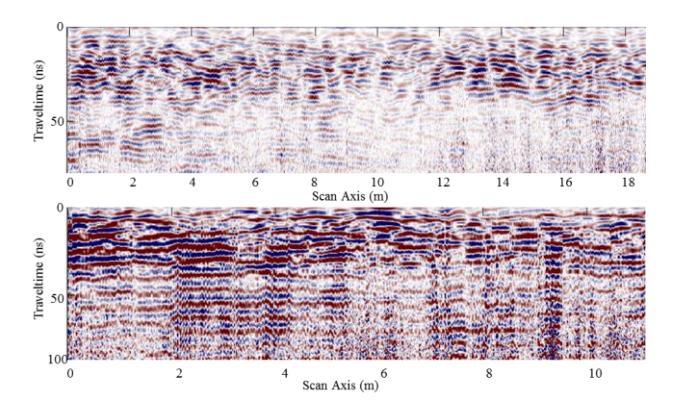
Figure 13. 270 MHz scans of vertical surfaces of the brick plinth of Nyatapola. Note the different display contrasts and horizontal axes.

The first major area of georadar (or GPR) investigation was the construction of the plinth. At Jaisi Dega, previous excavations of the plinth were carried out by the Department of Archaeology. These excavations provide information about the thickness of different layers that enable estimates of the velocity and dielectric constant for the areas with a brick in mud mortar. With this information, the radargrams collected with the 270 MHz antenna on the plinth at Nyatapola can be interpreted by comparison to the radargrams collected in the same manner at Jaisi Dega. (Figure 13, 14) Scans collected on the vertical faces of each plinth level indicate that, for both structures, the plinth is constructed of brick masonry with mud mortar as deeply as the georadar can penetrate (about 1.5m). (Figure 14) Additionally, the comparison with Jaisi Dega indicates that the outer surface of each plinth level is constructed with mud mortar as a regular brick masonry wall which extends down through the plinth to the lowest foundation level. In between these walls, the construction is dry stacked bricks, with less regular courses and no mud mortar. (Figure 14)

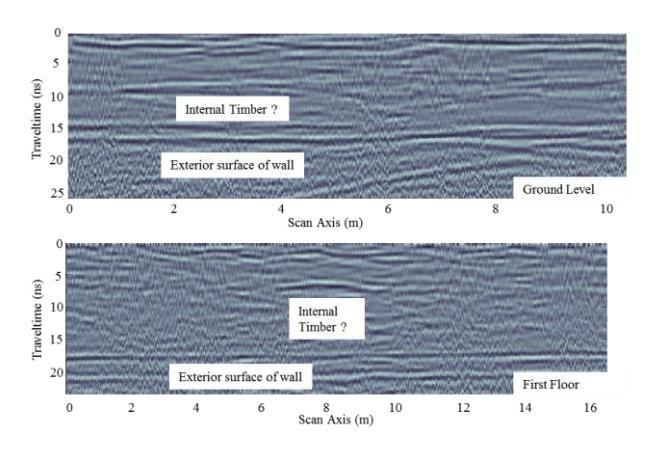
Figure 15. Internal elements with vertical continuity in each level in the ground floor (top) and first floor (bottom) walls.

The second major area of investigation was the construction of the walls, specifically investigating whether there are internal timber elements or other methods of ensuring vertical continuity between each level with offset walls. Much traditional construction from this period contains internal timber elements (Bernier, 1979), but it was unknown if Nyatapola Temple followed in the same tradition. This investigation was carried out with the 900 MHz antenna on the exterior of the lowest set of perimeter walls and interior of the ground and first floor of the temple. The ground level scans (at the top of the plinth) did not provide conclusive evidence about the nature of probable timber elements in the walls, but there is an obvious internal discontinuity. (Figure 15) This interface occurs directly under the outer edge of the second-floor wall, underneath its corner. This interface does not indicate a single vertical piece of timber but may indicate a more extensive internal framing system that supports the superstructure. In scans of the first floor, there is a vertically continuous internal element that is likely timber. (Figure 15) Because higher levels were inaccessible for scanning, the vertical continuation of timber elements cannot be confirmed in scans. However, because traditional construction practices are followed in the first two levels of the superstructure, it is likely that they are also followed in the upper levels and the timber continues vertically. Scans of the inner sanctum at Nyatapola did not provide enough information to compare to scans of the inner sanctum at Jaisi Dega.
