Drone-Based Photogrammetry for Pavement Deterioration Detection and Quantification in Airport Infrastructure

Guido Staub¹, Elisabet Jara¹,

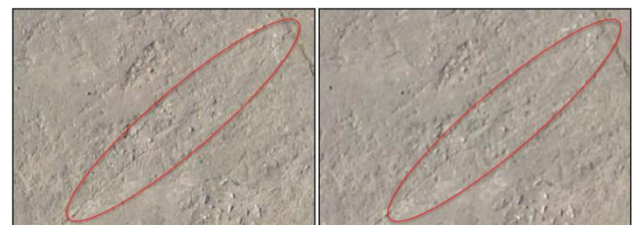
Figure 1. Observation of the same deterioration at flight heights of 10m (left) and 15m (right)

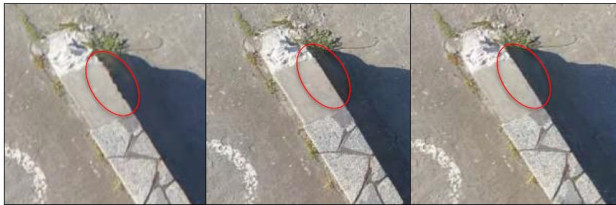
Figure 2. Comparison of a specific area within orthomosaics derived from different overlap combinations (left:70%-60%; centre: 80%-70%; right: 90%-80%)

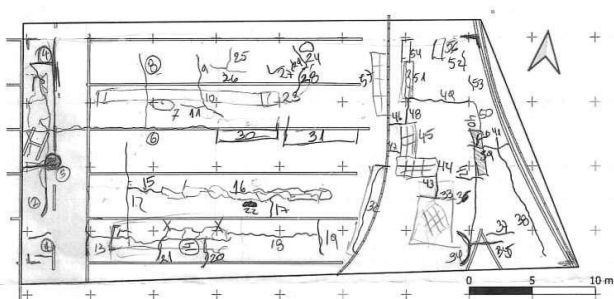
Figure 3. Location of damages detected in asphalt pavement using traditional field measurement

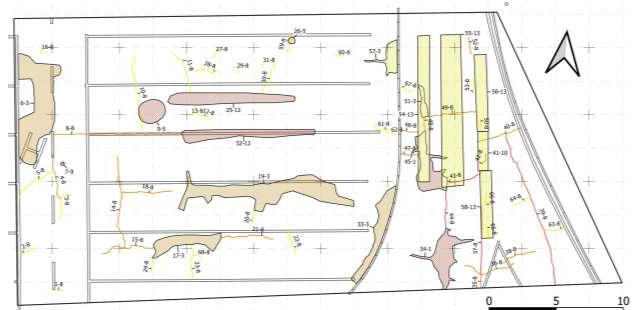
Figure 4. Location of damages detected in asphalt pavement using photogrammetric analysis
