DOCUMENTING MODERN MEXICAN ARCHITECTURAL HERITAGE FOR POSTERITY: BARRAGÁN'S CASA CRISTO, IN GUADALAJARA, MEXICO

Mezzino D., a Pei, W., a Santana Quintero, M., Reyes Rodríguez, R. b

Commission VI, WG VI/4

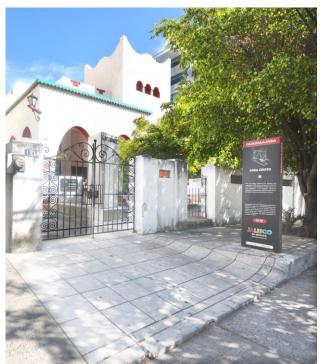
Fig.3 Casa Cristo by Luis Barragán. Photo taken by Davide Mezzino with a Nikon D800 DSLR camera with 50 mm lens.

It is possible to notice these influences in the *moresco* style of Casa Cristo, such as the Moorish tower, the entry porch featured by parabolic arches, the silver-gilded door, the textured plaster finishes, the stained glass windows (made from coloured blownglass bottle bases) and the unusual geometry of the back patio.

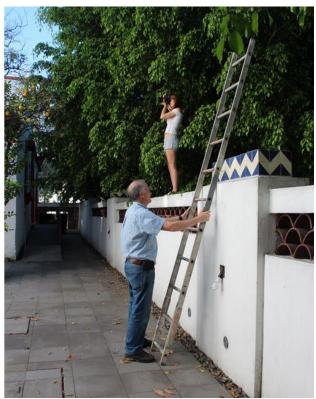
Fig. 9 Photos Capturing phase of the east façade for Photogrammetry.

Photos of the south and east elevations were taken according to the photogrammetric rule (3x3), established by CIPA (ICOMOS CIPA, 2013), using photogrammetric strips with 60-80% of overlap. The photos were taken at an appropriate scale in order to capture the details of the structure, given that the drawing set produced was at 1:50 scale. The photos were referenced to the Total Station data and the project coordinate system using the targets on the elevations captured in the same photos.

Photogrammetry models were created using the PhotoScan software. The model was opened in Autodesk Recap, and then exported into a compatible format into Autodesk AutoCAD, where the model was traced in order to produce line drawings. This approach had been replicated for both south and east elevations, as well as the roof plan.
