MODELLING FROM THE PAST: THE LEANING SOUTHWEST TOWER OF CAERPHILLY CASTLE 1539-2015

O. E. C. Prizeman^{a,*}, V. Sarhosis^b, A. M. D'Alri^c, C. J. Whitman^a, G. Muratore^d

KEY WORDS: Masonry, Tower, Point Cloud, Numerical Modelling, Terrestrial Laser Scanning

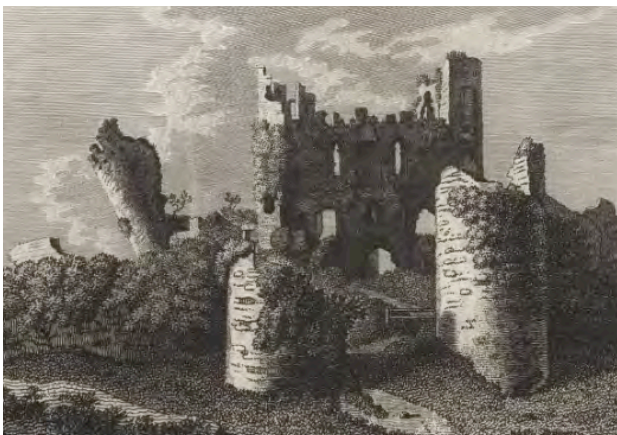
Figure 2. Caerphilly or Sengenneth Castle Pl2 P.Sandby Godfrey 1773 (Grose, 1783)

In 1774 Richard Godfrey, b.1728 and Sparrow depicted Caerphilly [sic] or Sengeneth castle in ruinous state – see figure 2. Grose quoted Leland who described in 1539: "Mr. Wood, of Bath, who lay on his back, for several minutes to view this dreadful ruin, its lineal projection, on the outer side, is not less than ten feet and a half". (Grose, 1783). In 1830 the tower is depicted as leaning eleven rather than ten feet: "This bulky fragment of the ruin is between seventy and eighty feet in height, and of a prodigious thickness. It hangs nearly eleven feet out of the perpendicular" (Gastineau et al., 1830). Using the measurements taken from the laser scanner today, it is evident that the greatest lean extends a little over 9ft (2.85m).

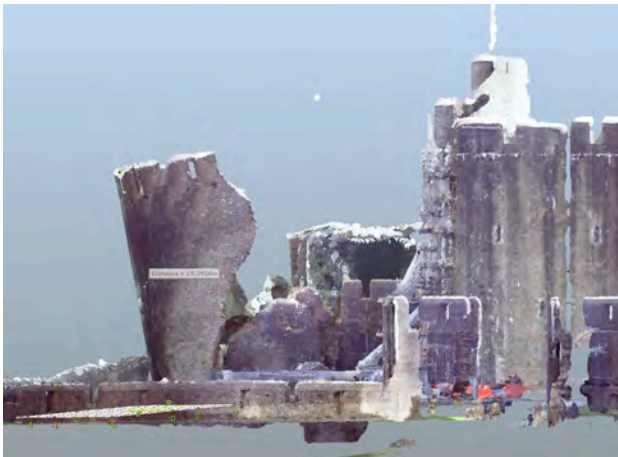
Figure 3. Elevation form laser scan

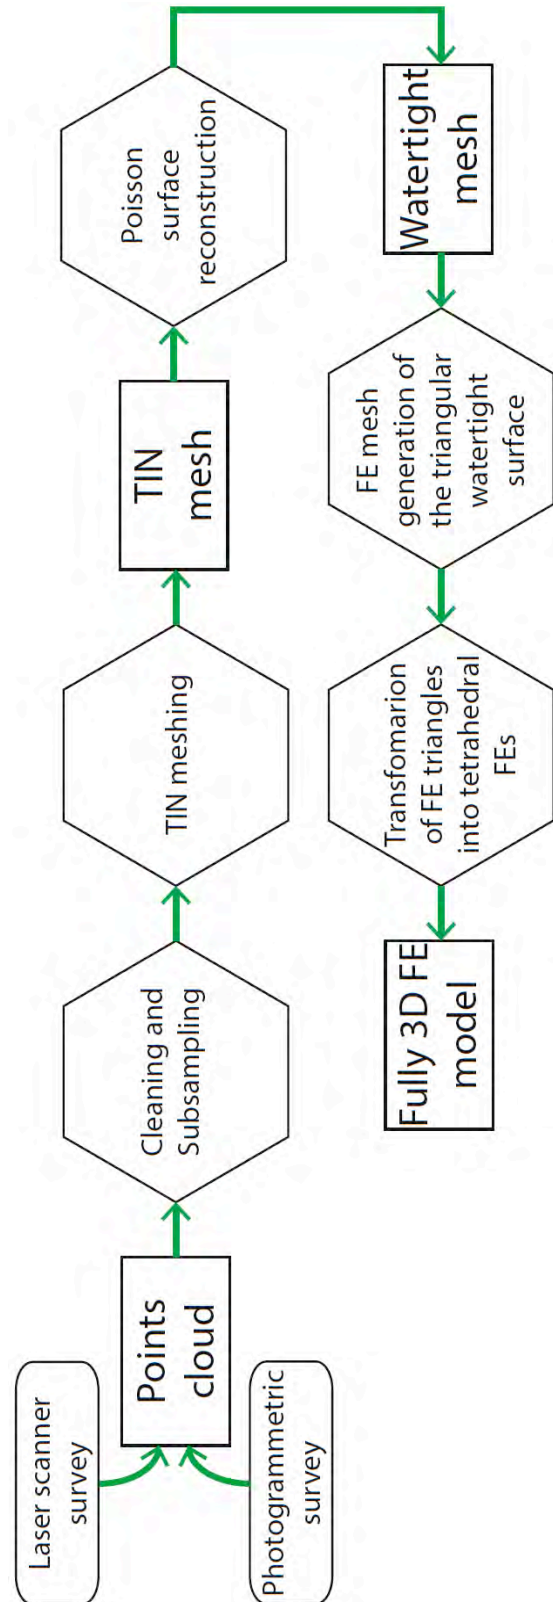
Figure 5. Automated FE mesh generation workflow.

Aiming at developing a detailed 3D FE model of the south west leaning tower of Caerphilly Castle, a simple processing of the point cloud (Figure 4) has been undertaken. Figure 5 shows the flowchart used for the development of mesh generation which was later used for the structural analysis.

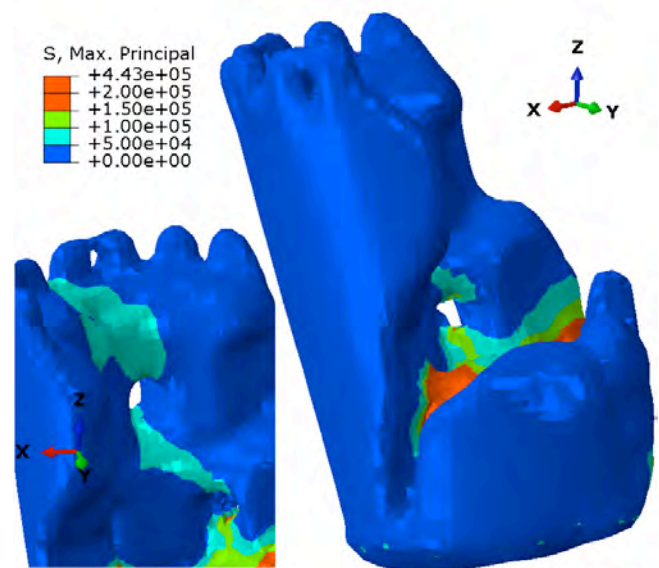
Figure 8. Tensile principal stress contour plot of the tower.

Figures 7 & 8 show the displacement and tensile principal stress contour plots, respectively. By selecting the worst case scenario of material properties (i.e. this could be due to deterioration of masonry), it was observed that the tower presents substantial displacements under dead load only, which induce the outward rotation of the tower, see Figure 9. Moreover, considerable tensile stress peaks arise, see Figure 10, which suggest the possibility of cracking conditions within the tower. Additionally, Figure 10 (left) highlights sub-horizontal tensile stress peaks which could induce a sub-vertical cracking of the tower's trunk.
