SUPERVISED CLASSIFICATION PROCESSES FOR THE CHARACTERIZATION OF HERITAGE ELEMENTS, CASE STUDY: CUENCA-ECUADOR

KEY WORDS: Preventive conservation, Monitoring, Imagery classification, Support Vector Machines, Roof structures, morphological mathematic

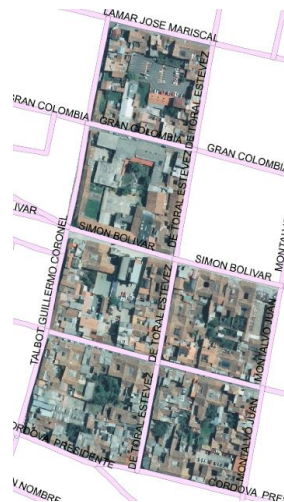
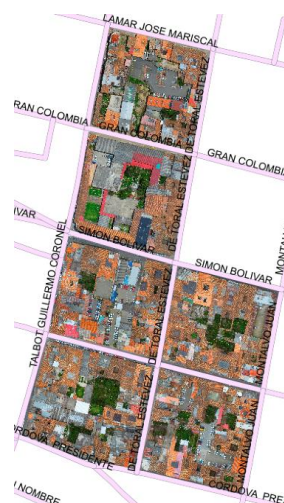
Figure 1(a). Rectified image of the selected building block
 Source: SIGTIERRAS, 2013

Figure 1(b). Rectified image of the selected building block
 Source: Municipalidad de Cuenca, 2016

For the development and methodology application, a building block of the historic centre of Cuenca was selected as study area (see figure 1 (a) and (b)). The selection was carefully done by identifying a building block of the city that present the following conditions: a) major number of registered alterations (Heras, Barsallo, Abril, & Briones, 2016) and b) the selected area have sufficient historical and current information for the required analyses.

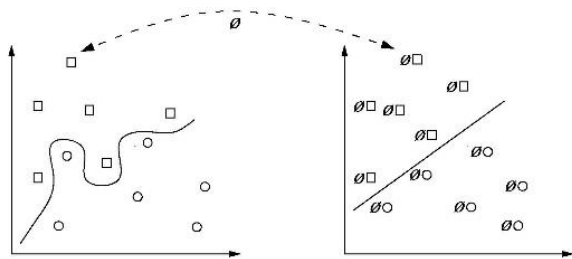
Figure 3. Use of kernel function to transform the original space into a space with different characteristics.
 Source: Authors, 2016

In this context, the hyperplane is defined by a function that depends on the multidimensional space in which the data is represented and separated. Therefore, in linearly separable cases, the hyperplane is a line. However, in the real life, the majority of cases are non-linearly separable cases. Thus, the use of Kernel functions are more convenient because it transforms the original space into a characteristic space (see figure 3), depending on the type of Kernel function applied: lineal, degree-p polynomial function, Gaussian or sigmoid. In this

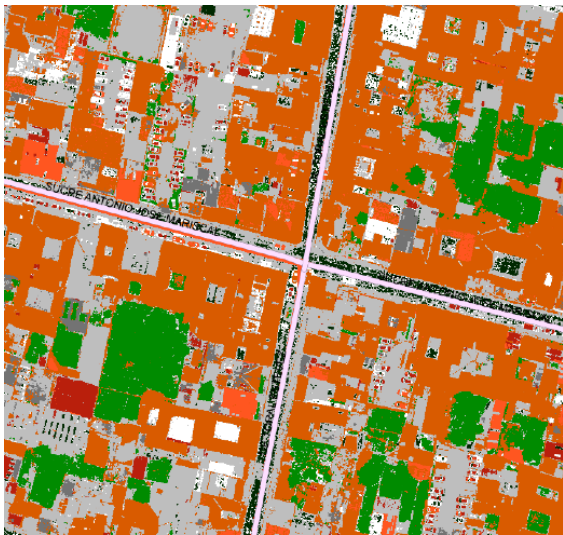
Figure 4. (b) 2016 raster image, 2,5cm/px. This image was classified and generalized with the SVM lineal function.
 Source: Authors, 2016
