APPLICATION OF DIGITAL HERITAGE DOCUMENTATION FOR CONDITION ASSESSMENTS AND MONITORING CHANGE IN UZBEKISTAN

O.Vileikis ^{a*}, F. Khabibullaev ^b

KEY WORDS: Digital Documentation, Cultural Heritage, Condition Assessment, Monitoring, Central Asia, Uzbekistan

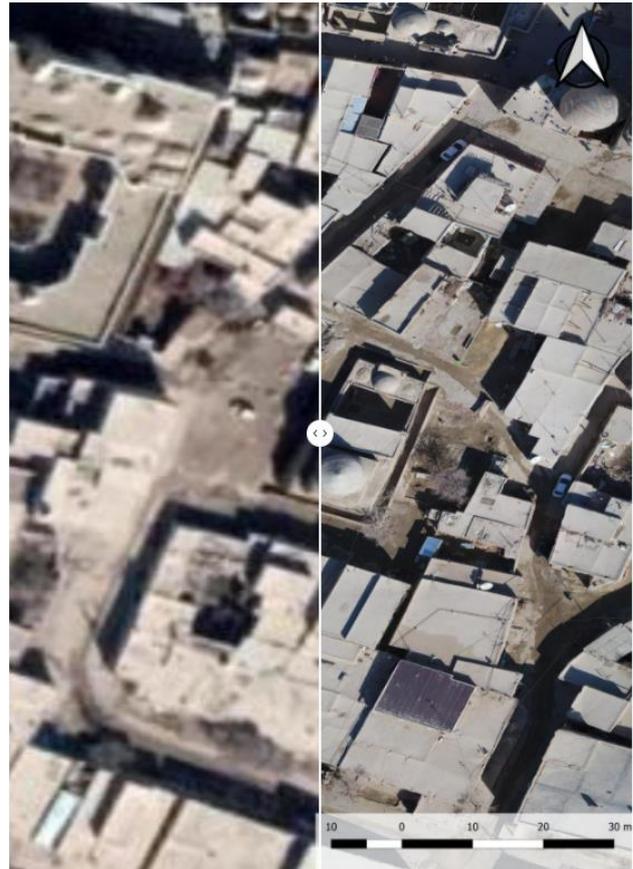
Figure 4. Aerial images. Google Earth (left) and CAAL Orthophoto – UAV flight altitude: 35m (right).

3D in Google Earth shows some historic buildings in Itchan Kala, but the images are low quality – intended only for visualisation and no high-resolution data for the Bogbonli Mosque was available. Also, the Google Earth image in 2020 was not good enough to clearly see the Mosque and its surroundings. Thus, there was a need to capture high quality data to acquire high levels of detail. Figure 4 shows the advantage of using aerial photogrammetry, to map the site. In this case, the Google Earth satellite image (see Figure 4 left) taken in 2020 has limited resolution in contrast to the orthophoto produced from the drone images captured at 65 m high (Figure 4 right). With the orthophoto the team was able to understand the Mosque in its mahalla -neighbourhood, from the air.

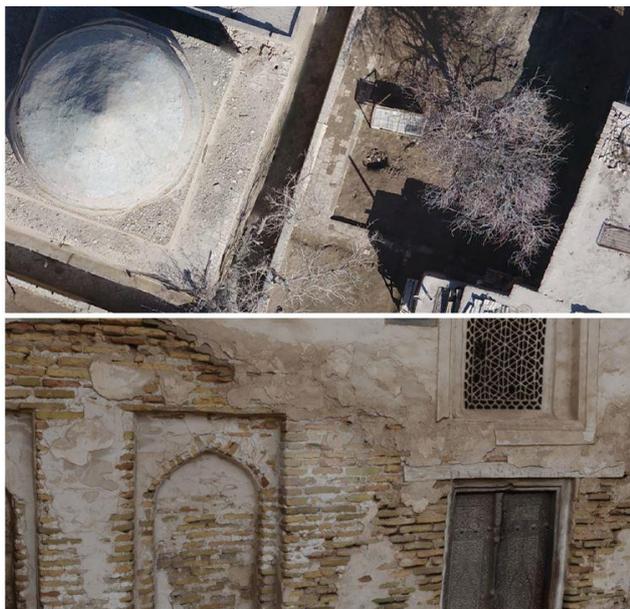
Figure 5. Detail of orthophoto of the roof and dome (upper) and detail of the 3D model of the north interior façade (bottom) of Bogbonli Mosque. Source: authors.

Orthophotos were also created from the drone aerial images taken at 35 m high. The orthophoto together with the 3D model, served to map the condition of the roof and dome and to identify the priorities for the conservation activities as shown in Figure

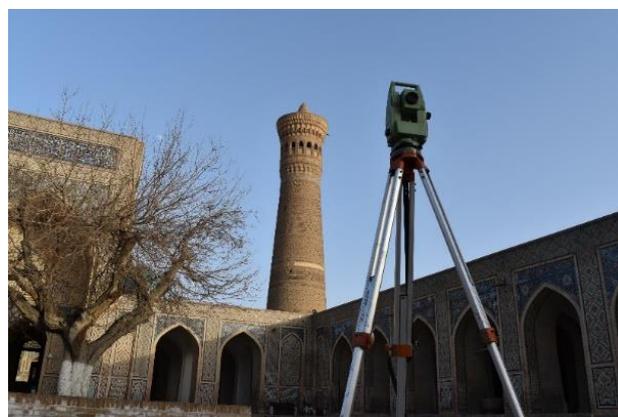
Figure 8. View of the Kalon Minaret from the courtyard of the Kalon Mosque. Source: authors.

Aerial photogrammetry was an excellent choice to reach high areas of the minaret of 47 meter high. For the first time the minaret Kalon was digitised as a 3D model (see figure 9). Details of the missing parts of the inscriptions and construction details of the bricks can be clearly seen for future research. In the 14 tiers of the horizontal design there is almost no repetition of pattern, including: bows with paired bricks; diamonds; girih; eight-pointed stars; and kufic letters as shown in figure 10.

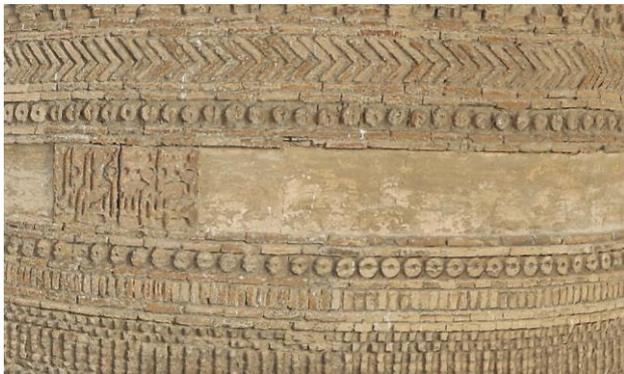
Figure 10. Detail of Kalon Minaret from the 3D model showing missing parts. Source: authors.

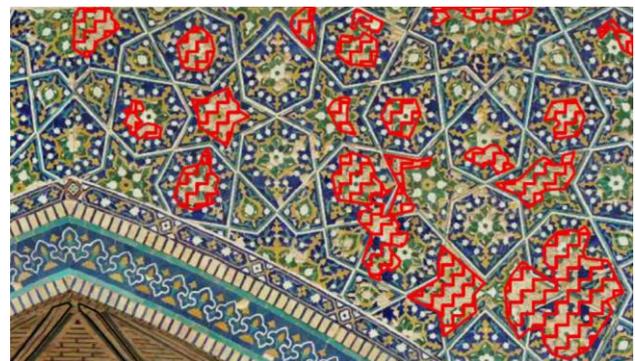
Figure 12. Detail of majolica of the of the north façade of Miri-Arab Madrassah with orthophoto as background. Source: authors.

As depicted in Figures 11 and 12, using the photogrammetric models, orthophotos of the façades were created to draw architectural drawings and map the condition of the buildings. Details of the majolica revealed missing parts or damaged areas, especially this was useful in higher areas that are difficult to reach such as in the Miri-Arab Madrassah.

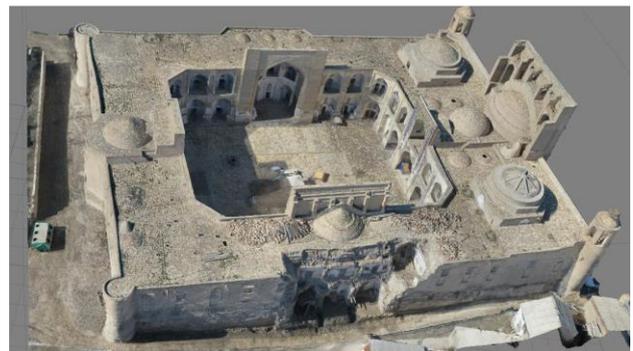
Figure 13. 3D model of Abdulazizkhan Madrasah. See collapsed wall in the lower centred part. Source: authors.

3D models of the buildings also served to understand the complexity of the buildings as seen in the example of the 17th century Abdulazizkhan Madrasah in Figure 13. In the last years, the building was used by craftsmen, renting the spaces for their workshops and shops. They were obliged to provide maintenance and repair to the premises they occupy. The greatest damage to the monument was caused by the work on lowering the cultural layers in the historical center of Bukhara in 2017. The works were carried out using heavy machinery without a scientifically grounded methodology. Consequently, the middle part of the wall of the eastern street façade and several rooms located behind it collapsed. Other parts of the building became as unstable as to be considered in an emergency condition, which, even before the lowering the soil, required reinforcement of the structures.

The 3D model served as a tool to discuss the damages with the conservation team. It aimed to support the preparation of the HIA for the emergency actions and conservation works by finding appropriate informed solutions.
