GEOMATICS DOCUMENTATION TECHNIQUES AS MONITORING TOOLS FOR RURAL BUILT HERITAGE IN NABÓN (ECUADOR)

1.3 Case study: Church of Nabón

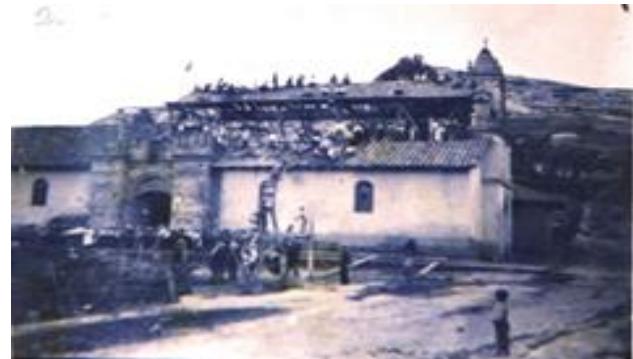
Figure 3. San Juan Bautista's church in Nabón (1940)

As it was mentioned before, the church was built at different stages, the first stage dates from the early nineteenth century, later an intervention was carried out by Aurelio Torres Alvarado and Juan José Cordero, approximately in 1925 (Terán, 1947). According to the photographic archive of Mr. Honorio Ochoa, a local art historian, in 1940 during the stage of the Priest Justo A. Torres, the central nave of the church was intervened, giving, as a result, a new building level (Figure 3).

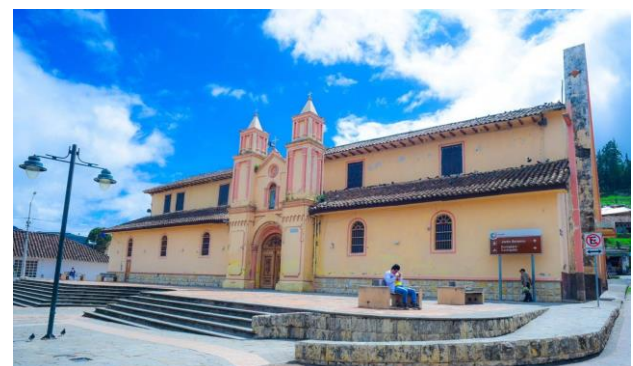
Figure 4. San Juan Bautista's church in Nabón (2021)

According to the mentioned photographic archive, in 1960, the church accesses were modified, particularly the south facade which was replaced by a modern-style concrete structure. In addition, the two existing towers of the main facade were extended; these transformations have been maintained until now (Figure 4).

Nevertheless, even if the church is considered the main building of Nabón, currently, its state of conservation is in bad condition. Different alterations such as moisture or biological actions are affecting this building. In this regard, the rehabilitation and enhancement of the main church is a fundamental and urgent project for the Municipality of Nabón.

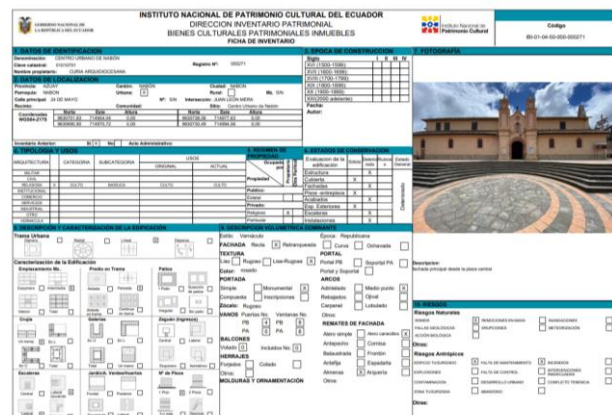
Figure 5. Nabón's church inventory file

Specifically, for the church of Nabón, a cultural heritage building inventory file was implemented (Figure 5).

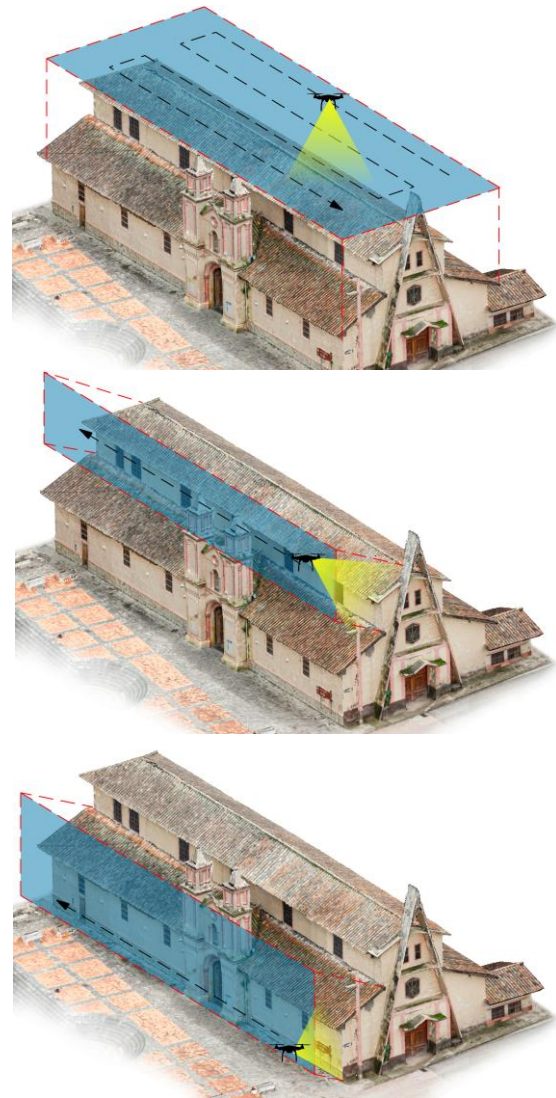
Figure 6. Flight plans with RPAS

The data acquisition was performed following 3 different flight plans (Figure 6). First, as is essential in any architectural documentation work, a zenithal flight was performed by raising the drone above the building and placing the RPAS camera completely perpendicular for optimal data collection, especially of the entire roof. In the following flight plan, the drone was positioned at the height of the second story and the camera was tilted down about 30 degrees, taking convergent photographs following a horizontal trajectory, parallel to the facade, capturing both the entire facade of the church and part of the roof already photographed. Finally, the third flight plan consisted of a flight with the camera at a slightly small angle upwards and at a height of half of the ground floor following, as in the previous flight plan, a horizontal trajectory parallel to the building.

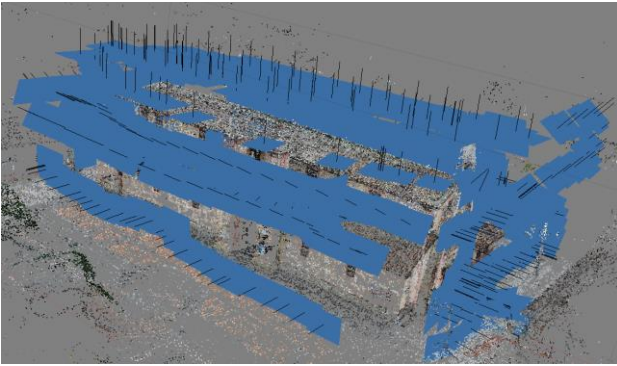
Figure 7. Nabón's church sparse point cloud

For the alignment of photographs, the software has two parameters to take into consideration: *Key Point Limit*, default 40,000, which is the maximum number of entities that the program will automatically extract from each photograph; and *Tie Point Limit*, default 4,000, which is the maximum number of homologous points that will be used for the matching process. The result is a sparse point cloud (Figure 7). The same figure also shows the layout of the real photographic acquisition.

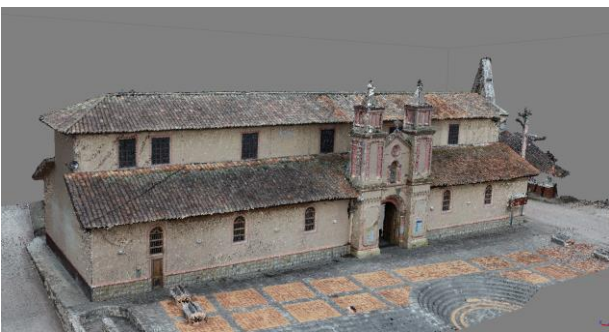
Figure 8. Nabón's church dense point cloud

At this point, it is advisable to take a look at the reports that the software generates, to know if the process is accurate and acceptable. More than 328 thousand homologous points have been found in the 472 oriented photos in about 45 minutes it has taken to perform the task. In addition, the reprojection error we have obtained was 0.7 pixel error, adequate for the case we are dealing with. From here, we can now create the dense 3D point cloud, in our case of high quality (Figure 8) that has taken about 2 days to process for the nearly 150 million points obtained. The computer used for processing was an MSI GP75 Leopard 9SD with Intel(R) Core(TM) i7-9750H CPU, 1TB SSD storage and all under a powerful NVIDIA GeForce(R) graphics card.

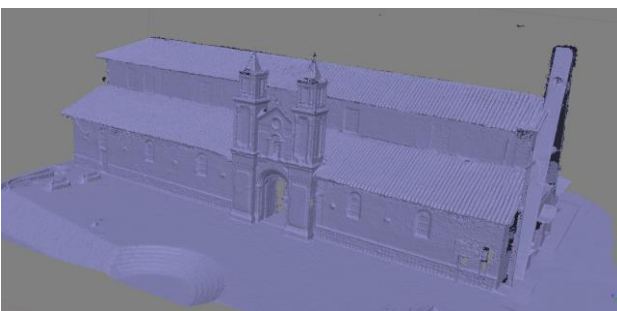
Figure 9. Nabón's church 3D model

2.2.2 3D Modeling: The objective at the present time is to transform the dense point cloud to a 3D model clean of noise and free of holes, i.e., a high-quality 3D model. Regarding the software used, the 3D model was created with Agisoft Photoscan (Figure 9).

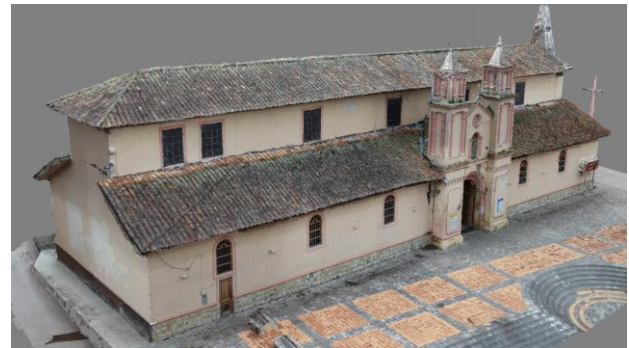
Figure 10. Nabón's church textured 3D model

Finally, when the 3D model is polished and free of holes, it has been textured in a photorealistic way (Figure 10), again in Agisoft Photoscan, with the photographs that were used for its creation. In the future, we are also planning to take hyperspectral and thermographic imagery since these imagery are very useful for the detection and localization of alterations in the building (Lerma, 2001; Sidiropoulou-Velidou, Georgopoulos and Lerma, 2012).

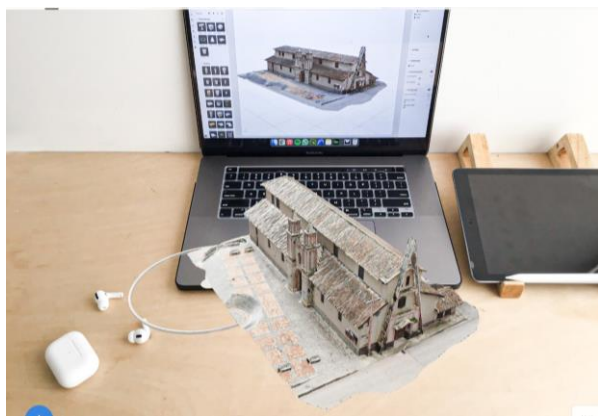
Figure 11. Nabón's church in augmented reality (AR)

Consequently, it has been seen appropriate to decimate the 3D mesh of the object in order to reduce its size or weight to optimize its visualization on mobile devices, thus having an object with 200.000 faces and 172.241 vertices which is much more optimal for visualization issues.

Once the reduced object is obtained, with the help of Adobe Dimension software the object is opened, the generated texture is placed as image filler with high quality, and it is exported in a USDZ file which can be viewed on any mobile device with an application for this purpose (Figure 11).

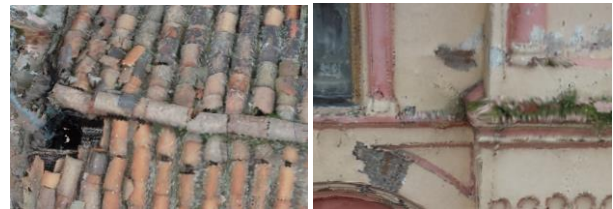
Figure 14. Damages in the church of Nabón

The photogrammetry as a documentation tool allows a quick and precise location of damages or existing problems in the building (Figure 14) such as a large hole in the roof and the large amount of moisture and detachment of existing material on the facades. Moreover, the continuous monitoring of structures in rural areas can be supported by these documentation tools but also by structuring the data for further adequate analysis.

In the case study, the church, it has been possible to check and start monitoring the pathologies suffered in its building, such as a large hole in the roof and the large amount of moisture and detachment of existing material on the facades. Thanks to this documentation and monitoring work, the municipality has already undertaken institutional actions to obtain funds for the rehabilitation of the church.
