## Geospatial information based on UAV for socio-environmental problems in an urban river

Andrea Nathaly Escobedo Tamez, Fabiola D. Yépez-Rincón \*, Yadira Zulema Antonio Durán, Mariana Pérez Martínez, Milena Mesa Lavista, David Clemente López Perez and Carlos J. Ábrego Góngora

Faculty of Civil Engineering, Universidad Autónoma de Nuevo León, San Nicolás de los Garza, Nuevo León, México

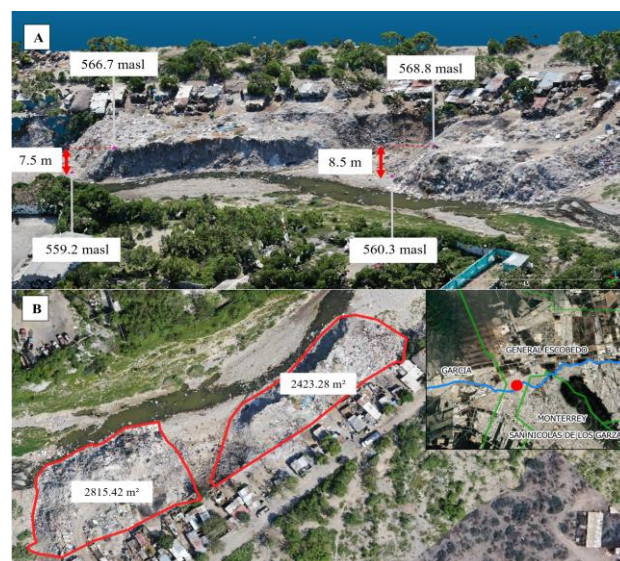
Fig. 6. Accumulations of solid waste on the river, showing A) Heights and elevations, and B) Surface area of the waste.

Within the same sections, five zones of solid waste accumulation were identified, and their respective heights, surface areas, and estimated volumes were calculated. (Fig. 6 and Table 2).

The largest accumulation has a height of 8.5 m, a surface area of 2,874 m<sup>2</sup> and an estimated volume of 1,627,142.78 m<sup>3</sup>.

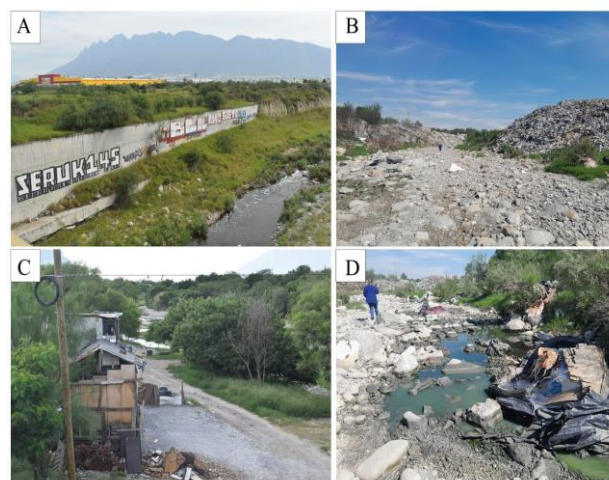
Fig. 8. Different problems were recorded with ground-level photos. A) This photograph shows a concrete channel used for river drainage, the wall of which is covered in graffiti, reflecting a possible lack of maintenance and surveillance in the area. Photograph taken from a bridge. B) In this ground-level image, accumulated waste is observed on the riverbed; this accumulation was analyzed using a point cloud. C) On the banks of the Pesquería River, it is common to identify homes that are located within the floodplain; these are usually irregular homes that are not legally registered. Photograph taken from a bridge. D) In this image, accumulations of solid waste are observed on the riverbed; this scene is constant in different areas of the main channel.

Among the main identified socio-environmental problems identified with ground level imagery are the accumulation of solid waste, such as plastics, cardboard, tires and abandoned furniture, in the riverbed, as well as in green areas and public

spaces, leading to water pollution, soil degradation, and visual deterioration in urban zones (Fig. 8).
