Analysis of socio-environmental problems in the La Silla River, Monterrey, México: An approach with UAV geospatial data (LiDAR and RGB)

Keywords: UAV; point cloud; river; socio-environmental problems

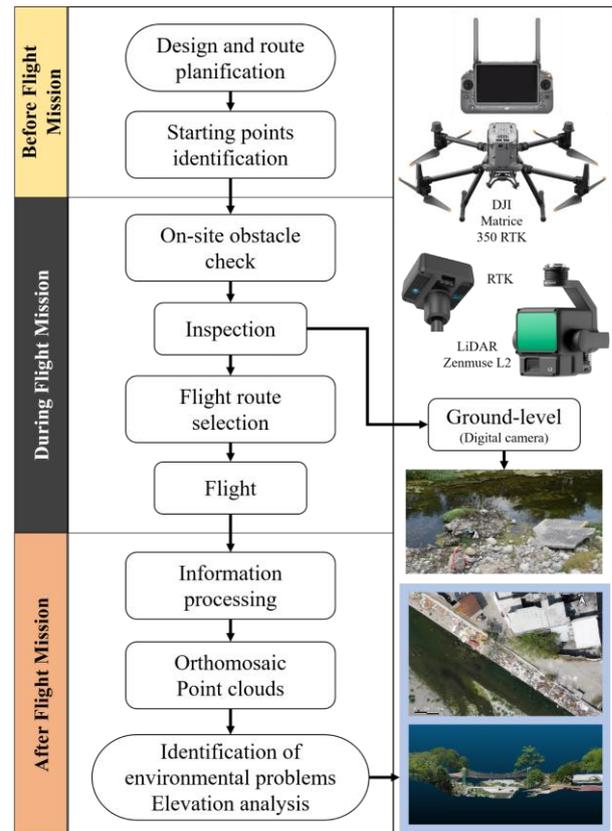
Figure 2. Workflow.

Figure 2 illustrates the information acquisition workflow using a UAV. Data acquisition was performed using a DJI Matrice 350 RTK UAV, equipped with an integrated LiDAR L2 sensor. The UAV mission covered an area of approximately 1596.36 Ha, including the river channel and adjacent buffer zones.

The flight was executed at an average altitude of 97.2 meters above ground level and a consistent cruising speed of 9.43 m/s.

The LiDAR sensor operated in a repetitive scan mode with a $70^\circ \times 3^\circ$ field of view, a pulse repetition rate of 240 kHz, and a scan rate of 1200 kHz. This configuration provided high-density point cloud data (124 points/m²) with a ground beam footprint of approximately 117 mm \times 39 mm.

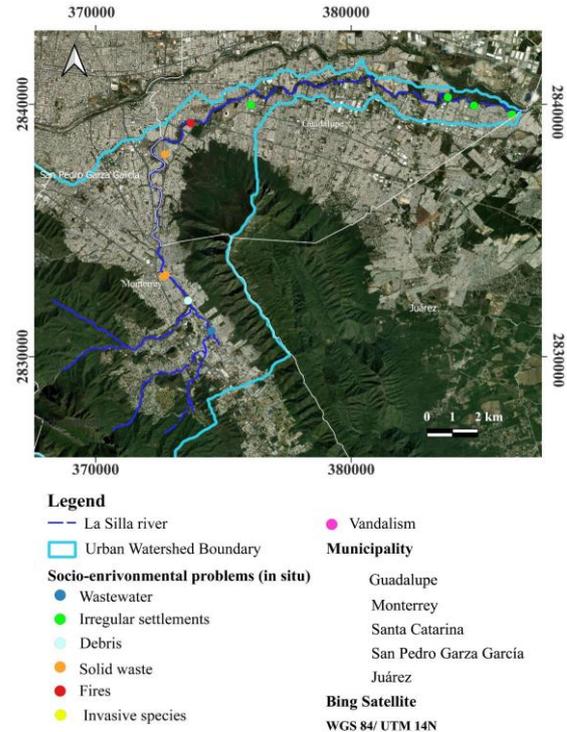
Fig. 3. Map of socio-environmental problems of the La Silla River recognized by field work (in situ).

The socio-environmental issues identified through fieldwork were primarily concentrated in the municipalities of Monterrey and Guadalupe, where a total of 24 affected sites were recorded (Fig. 3).

Among these, five locations exhibited evidence of wastewater discharge, while four sites corresponded to informal settlements, apparently situated within the river's floodplain.

Additional issues included the presence of invasive plant species and fire incidents, mainly associated with the burning of solid waste. The most frequent problem observed in both municipalities was the accumulation of solid waste, documented at nine sites, many of which were linked to irregular dumping activities (Fig. 4).

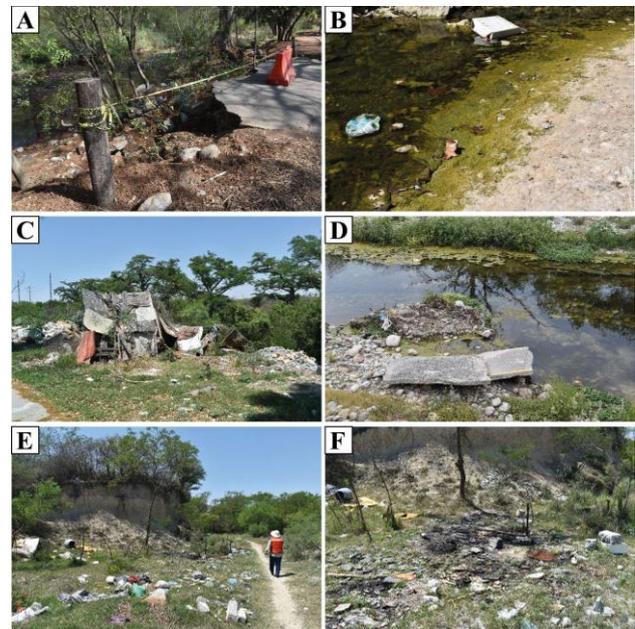
Fig. 4. A) Debris from a former road that used to cross the riverbed. Although the area is cordoned off, it lacks proper signage, posing a risk. B) Solid waste, mainly plastics and household appliances, within the river. C) Irregular settlements can be seen along the riverbank. These structures are uninhabited and exhibit signs of having been exposed to water flow, as evidenced by their partial destruction. D) Debris from what used to be a road along the riverbank is visible. E) Depicts scattered solid waste on the riverbank, including plastic bottles and bags, as well as appliance debris. F) Burned solid waste is shown,

indicating that this might be a clandestine dump site where waste is incinerated.

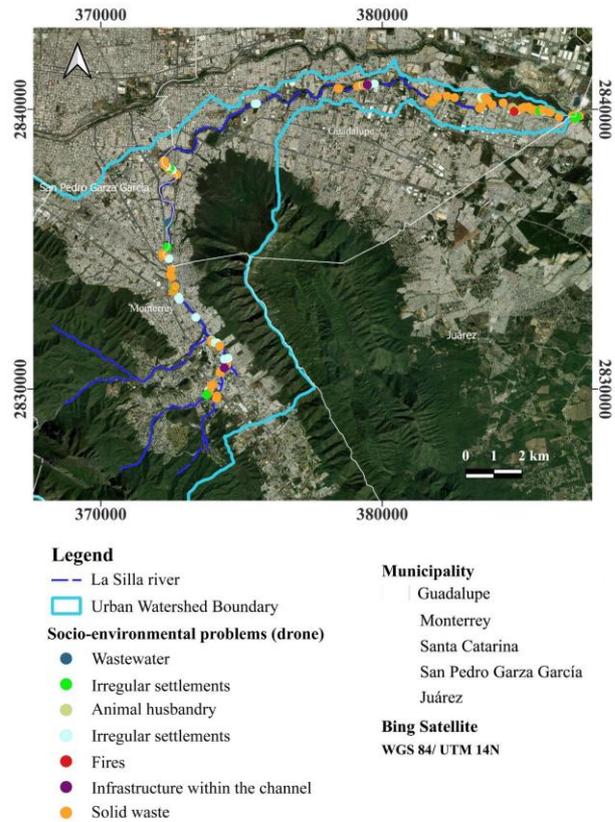
Figure 5. Map of socio-environmental problems of the La Silla River recognized by drones (UAVs) imagery.

The main issues identified were: wastewater discharge, informal settlements, animal husbandry, debris, fires, infrastructure built within the river, and solid waste, the latter being the most persistent problem along the river's course (Table 1 and Fig. 5).

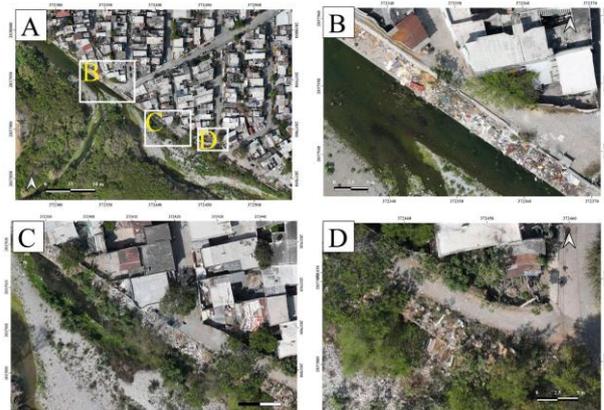
Fig. 6. A) shows approximately 300 meters of the La Silla River channel. In this specific transect, the river separates the populated area to the north from the riparian vegetation to the south. The riverbank adjacent to the populated area is affected by solid waste. Panels B), C) and D) provide detailed views of the solid waste in this transect.

Figures 6–8 illustrate socio-environmental issues identified using UAVs. Data resolution is transcendental to locate and analyze these types of problems in urban rivers.

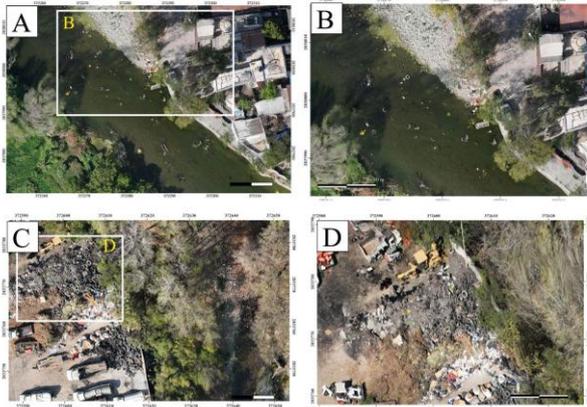
Fig. 7. A) Solid waste directly in the river. Panel B) highlights waste composed mainly of tires and furniture. C) Accumulation of tires in what appears to be a dump or recycling center located on the riverbank. Panel D) provides a close-up of this issue, revealing that the solid waste includes not only tires but also various plastic waste and furniture

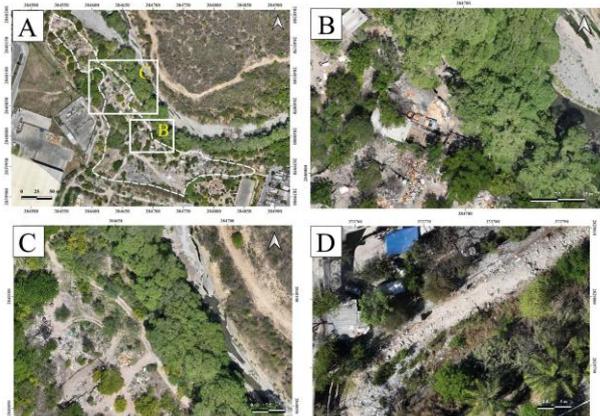
Fig. 8. A) The area, approximately 0.025 km², is being used as a dumping site and is located next to the river (outlined with a white dashed line). Panels B) and C) show close-ups of panel A, revealing settlements and solid waste in the area. D) Shows informal settlements along the riverbank, as well as solid waste scattered throughout the riverbed.

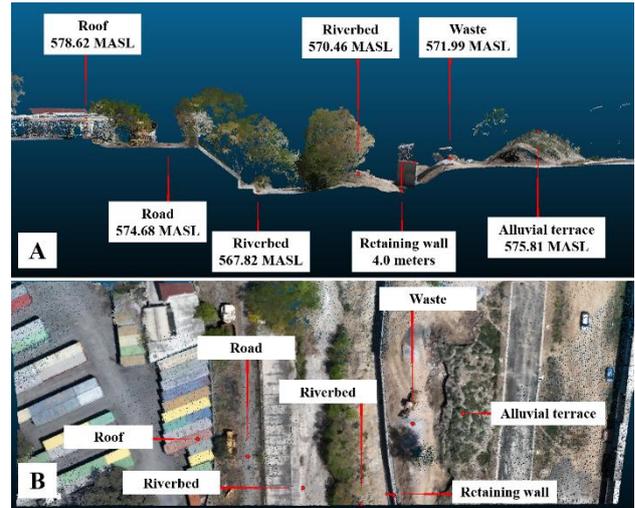
Fig. 9. Section of the La Silla River in the municipality of Monterrey. A) Profile view and B) Top view. Elevations expressed in meters above sea level (MASL).

Figure 9 shows the profile and top view of a section of the river located in Monterrey. Here, the left bank of the river was channeled, and a 4-meter-high retaining wall was placed on the right bank. Warehouses and debris disposal sites are observed very close to the sides.

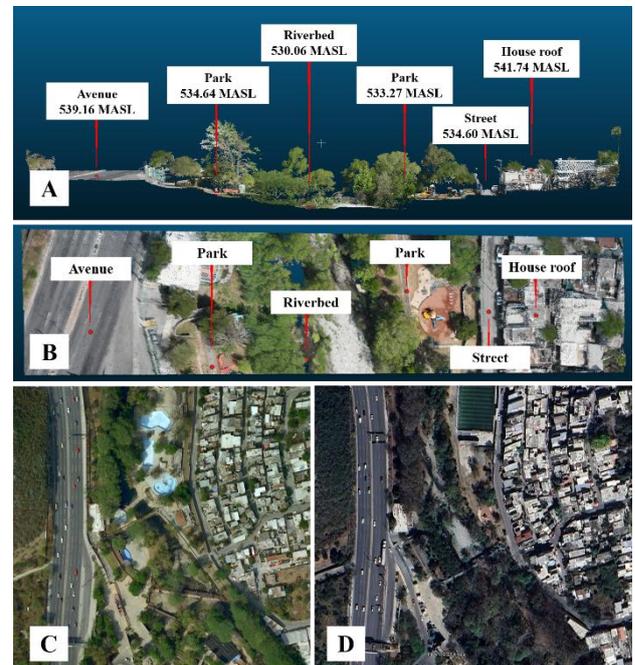
Fig. 10. Section of the La Silla River located in "Parque Canoas," Monterrey. A) Profile view, B) Top view, C) Satellite image from April 23, 2009, and D) Satellite image from February 23, 2025. Elevations expressed in meters above sea level (MASL).

Figure 10 illustrates Parque Canoas in the municipality of Monterrey, which currently features a pedestrian bridge, playgrounds, and a community center. Image C shows the park in 2009 before the arrival of Hurricane Alex, where the infrastructure was more extensive, including swimming pools, courts, and outdoor theaters, among others, which were swept away by the river. Image D is a present (2025) satellite image.

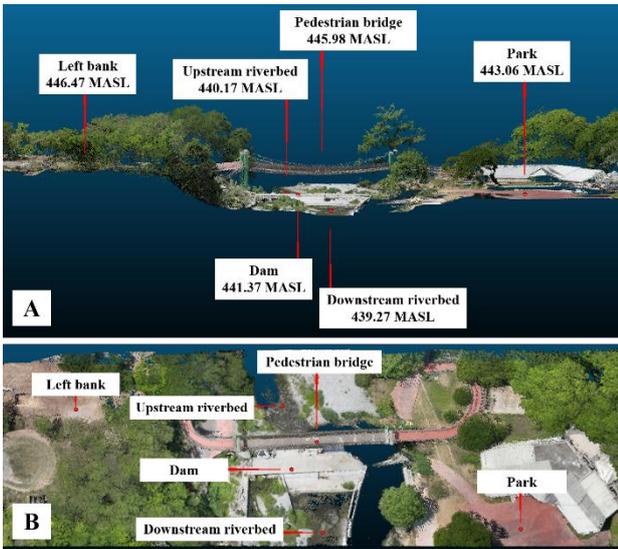
Fig. 11. Section of the La Silla River located in "Paseo Río La Silla Unidad Pipo," Guadalupe. A) Profile view and B) Top view. Elevations expressed in meters above sea level (MASL).

Figure 11 presents the case of "Paseo Río La Silla Unidad Pipo", which has a park with recreational areas on the right bank of the river and a dam approximately 2 meters high over the riverbed.

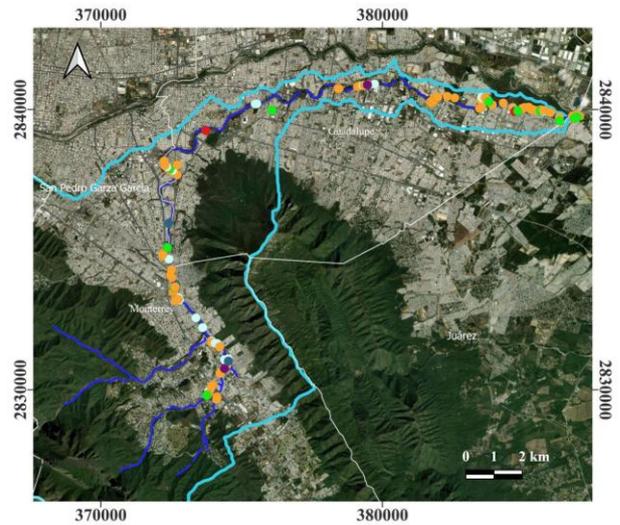
Fig. 12. Map of the socio-environmental problems identified along the Río La Silla floodplain in the Monterrey metropolitan area, Nuevo León, Mexico. The map displays different issues such as solid waste, wastewater, decline in fauna, and irregular settlements, among others.

Based on the analysis conducted along the La Silla River using UAVs' orthomosaics and fieldwork, 172 sites with socio-environmental issues were identified (Table 2 and Fig. 12).

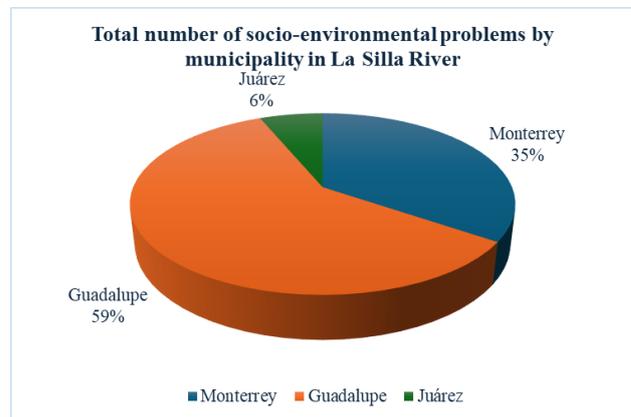
Fig. 13. Percentage diagram of the total number of socio-environmental problems identified by municipality.

6% of the issues were located in the section within the municipality of Juárez (4.7381 km), 35% in Monterrey (32.0453 km), and 59% in Guadalupe (22.6956 km) (Fig. 13).

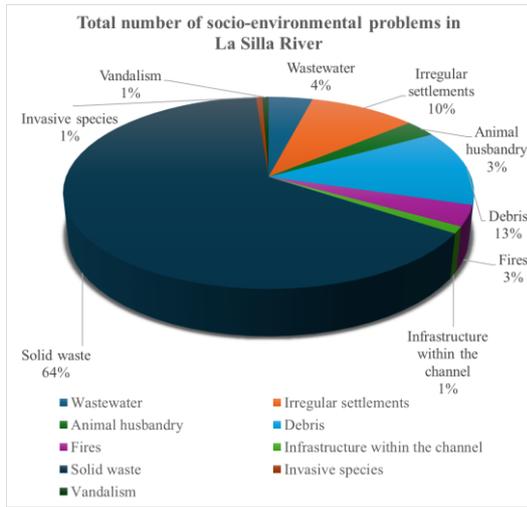
Fig. 14. Percentage diagram of the total number of socio-environmental problems identified along the La Silla River.

The highest percentage of socio-environmental issues along the La Silla River corresponds to solid waste, accounting for 64%, followed by 13% related to construction debris dumping, and 10% to irregular settlements (Fig. 14).

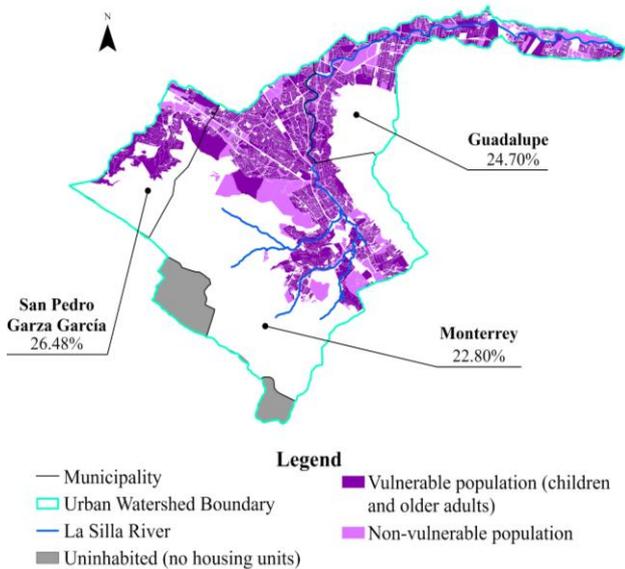
Note: The percentage represents the proportion of vulnerable population (children and older adults) with respect to the total population

Fig. 15. Map of vulnerable population (children and older adults) within the urban basin of the La Silla River.

Figure 15 illustrates the proportion of the population considered vulnerable due to age. Significant concentrations of vulnerable individuals were identified along the main course of the La Silla River. This spatial distribution is particularly relevant for defining priority areas in terms of civil protection and risk-sensitive urban planning.

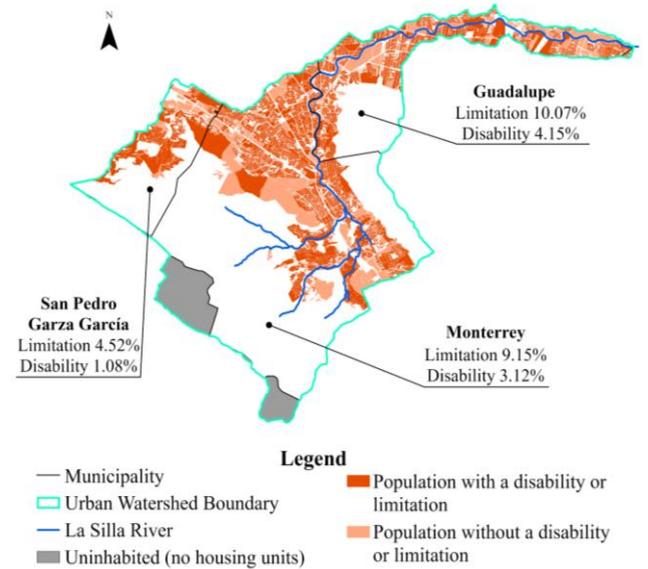
Note: The percentage represents the proportion of population with a disability or limitation relative to the total population

Fig. 16. Map of population with a disability or limitation within the urban basin of the La Silla River.

Figure 16 shows the proportion of the population with some form of disability or limitation in performing daily activities. Guadalupe exhibits the highest values for both limitations (10.07%) and disabilities (4.15%), followed by Monterrey and San Pedro Garza García.

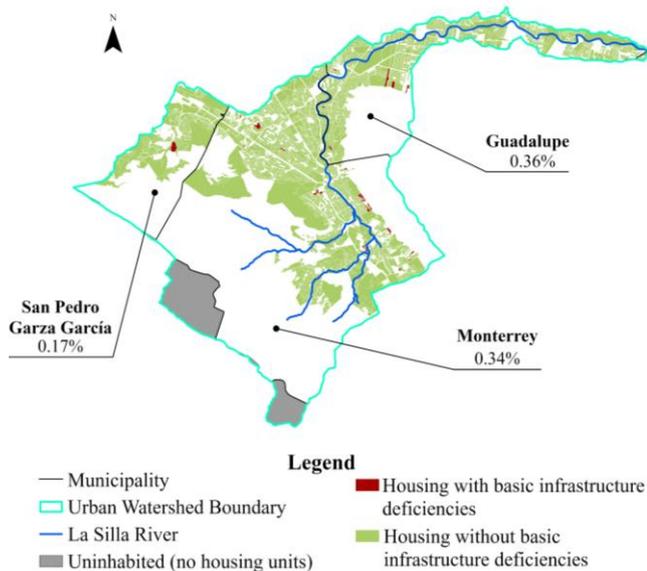
Note: The percentage represents the proportion of households with deficiencies in their basic infrastructure

Fig. 17. Map of households with deficiencies in their basic infrastructure .

Figure 17 shows the distribution of homes lacking basic services. Although the percentages are low at the municipal level (San Pedro Garza García: 0.17%, Guadalupe: 0.36%, Monterrey: 0.34%), specific areas within the basin are concentrated, mainly in the north and northwest.
