## Post-Disaster Building Damage Assessment Using 3D Surface Models Derived from Unmanned Aerial Vehicle (UAV) Imagery

Alyssa Patricia J. Manzano<sup>1</sup> and Ariel C. Blanco<sup>1,2</sup>

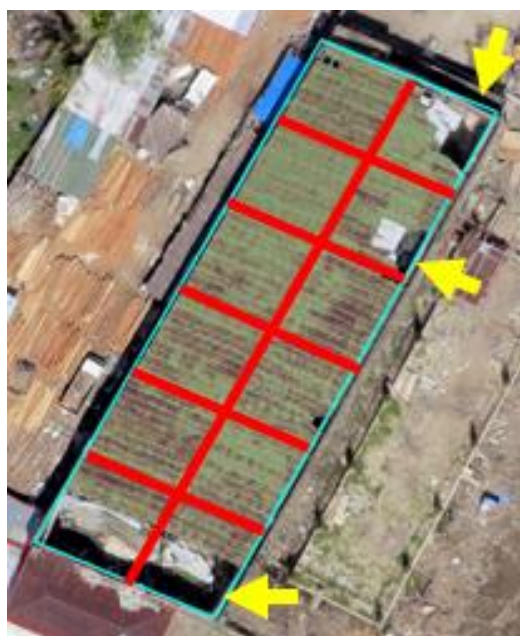
Figure 3. Building with damage rating of 2. Yellow arrows show the damage indicators. Damaged area is approximately less than 20 percent of the total building polygon's area.

The damage rating system developed and used in this study is remote sensing-based. Remote sensing data, in this case UAV data, is often limited to top or vertical view and does not include the façades of buildings. This building damage rating system uses percent damaged area (PDA) to rate building damage. The PDA is determined by visually estimating the damaged area as a proportion of total top view area of the building. The damaged area is an area on the building that visually contains any of the physical damage indicators. Damage indicators include any markers and proxies that represent damage to buildings. For this study, the physical damage indicators were vegetation or collapsed trees, rips, folds, warps, holes, changes in roof color, tarpaulins, debris, collapsed building parts, and exposed roof parts. The PDA was then used as the basis for the damage rating (DR) and for formulating the binary and ternary classification rules detailed in Appendix Table A1. Figure 3 shows a building with DR of 2.

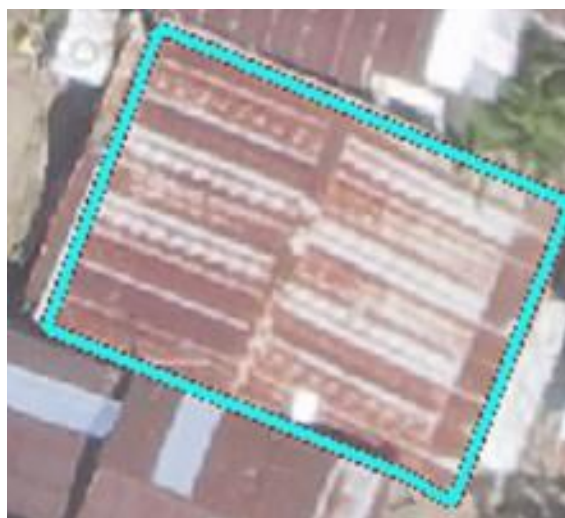
Figure 4. Building with roof made of rusted corrugated sheets. The rusted and uneven texture of the roofing material introduced noise in the texture attributes, leading to frequent misclassification as damaged despite being intact.

The buildings with roofs made of corrugated metal sheets (Figure 4) were often misclassified as damaged by models using high resolution datasets. Undamaged roofs with homogenous color were classified correctly, but those that had rusted corrugated sheets were most often misclassified as damaged. The misclassification was because of the texture attributes since models that used elevation only attributes rarely made the same mistake. Although some buildings with corrugated metal roof sheets were correctly classified, the results show there is a need for more samples with this type of roof in order to improve classification performance. Many buildings were found to have this type of roofing material, often

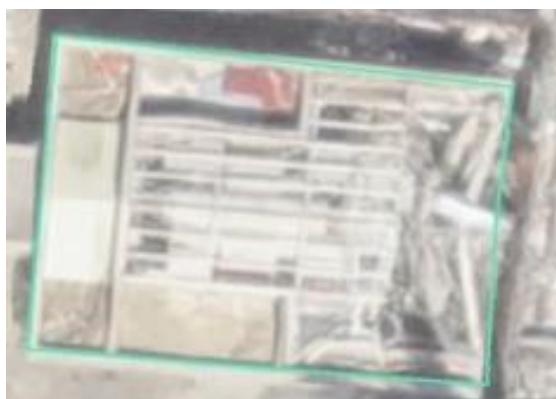
Figure 5. Building with exposed roof beams. These features can cause misclassification in elevation-only models due to limited nDSM resolution.

Models that used elevation attributes only had difficulty in correctly classifying buildings with exposed roof beams. This might be due to the fairly low resolution of the nDSM image, and because A1 and A2 models only considered the minimum value of nDSM. Buildings with very low minimum nDSM values tend to be classified as damaged. The building in Figure 5 however, had high minimum nDSM due to the resolution. The spaces between the roof beams cannot adequately be seen using the nDSM image. Such buildings were correctly classified when texture and elevation attributes were used together.

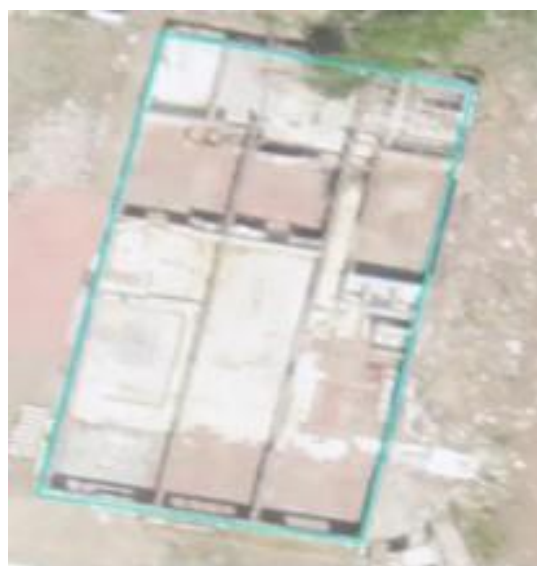
Figure 6. Completely damaged building misclassified as partially damaged. Although elevation attributes correctly classified it, using texture attributes led to misclassification due to conflicting cues.

those with PDA of 70% to 90% had to be labelled partially damaged following the damage rating rules of this study but can already be considered unlivable or completely damaged. Often, when models using texture attributes only are wrong and models using elevation attributes only are correct, models using both attributes would result to a wrong classification. Figure 6 shows a building that was misclassified by O-B1-t as partially damaged, but correctly classified by O-B1-e as completely damaged. Only some walls and floor fixtures are left. Using both texture and elevation attributes still resulted in a misclassification.
