DEGRADATION OF HISTORIC MASONRY BY ANALYTICAL AND DIGITAL PHOTOGRAMMETRY: A QUANTITATIVE ANALYSIS

Maria Grazia D'Urso¹, Constantino Luis Marino², Joel Aldrighettoni³

¹Department of Engineering and Applied Sciences, University of Bergamo, Viale G. Marconi, 5 Dalmine (BG), 24044, Italy - mariagrazia.durso@unibg.it

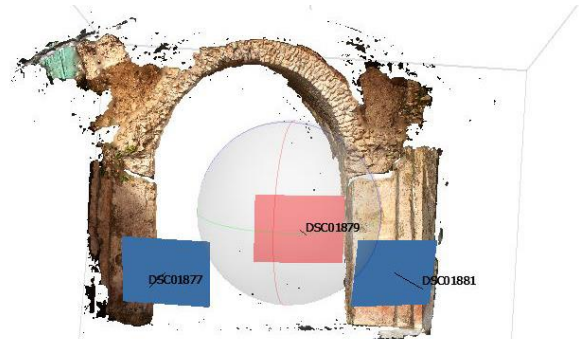
Figure 9. Digital processing images by ADSR900

Therefore, from a semi-analogical survey approach we switched to a fully automated system with raster image generation, obtained by processing only three photo shoots, as shown in Fig.9, achieving a millimeter accuracy.

For a comparison three images, one central and two lateral, acquired with Sony ADSR 900 camera, in the 2010 survey, were processed with Agisoft Photoscan software version 8.3.1, with automatic production of a 3D model.

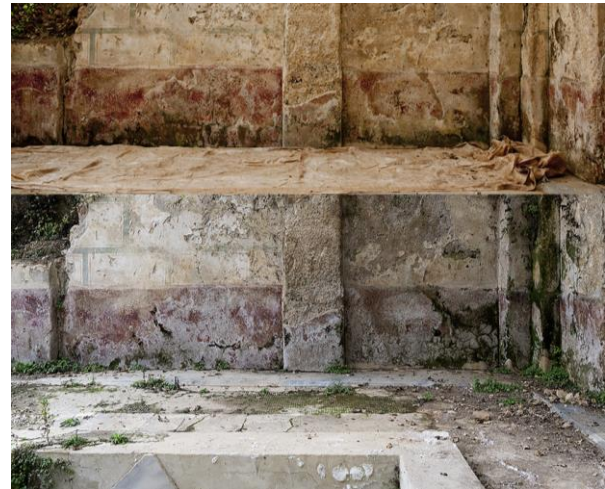
Figure 13. Visualization of degradation images, in the surveys 2010-2019, of the external side wall

The decay surface's widening is particularly evident in the outer left wall, as shown by the comparison of the two surfaces taken in the 2010 survey above on the 2019 survey, as depicted in Figure 13.

As shown in the comparison of Figure 13, the measurements highlight a portion affected by high humidity at the right corner of about 0.71 sq. m. out of a total wall area of about 3.38 sq. m., and an area of about 0.57 sq. m. depicted at the left front, where there was an almost complete loss of the red color of the fresco due to the presence of white saltpeter powder consisting of potassium carbonate.

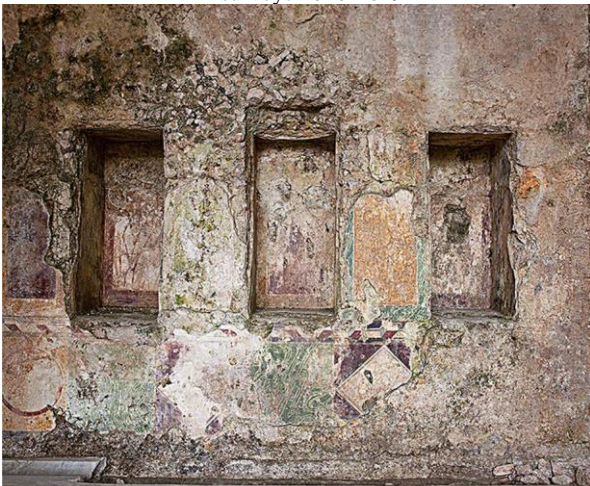
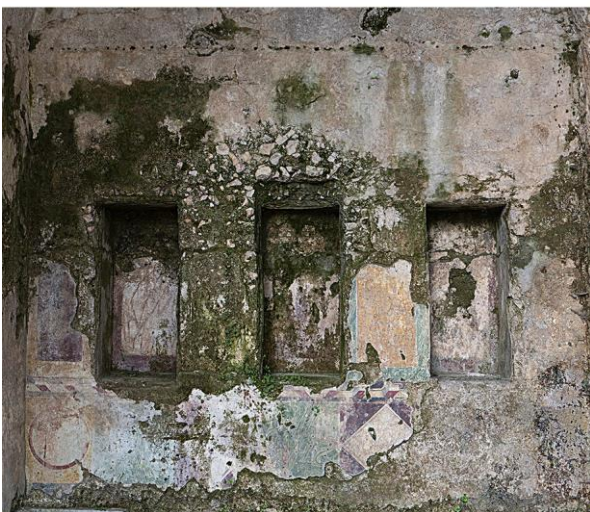
Figure 16. Comparison of degradation images, surveys 2010-2019 of the back wall

More degradation is evident in the background part depicted in Figure 16 related to the comparison of images from the 2010 and 2019 surveys obtained by matching homologous points. Water seepage from the embankment behind caused the formation of abundant vegetation and damage to the plasterwork and frescoes. The presence of moisture delimited in Figure 17 by the yellow-colored contours, respectively in the 2010 and 2019 surveys, affects areas covered by vegetation and mold; they increased from a value of about 1 square meter in 2010 to a much larger value of about 5.58 square meters in 2019.

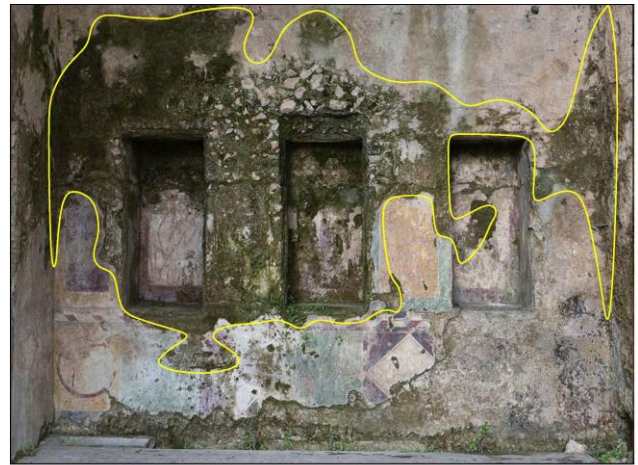
Figure 17. Degradation increase measured in the survey 2019

The determination of these measurements was semi-analogically achieved. An analogical image acquired with a Rolleimetric with 121 reseau points was first transformed into a digital image by scanning and then transformed into an orthoplan on which the areas of degradation were measured manually using appropriate software. This approach was necessary because the photogrammetric cameras used in the survey dated 2010 were still mostly analogical. Conversely, the subsequent 2019 survey was entirely done digitally.

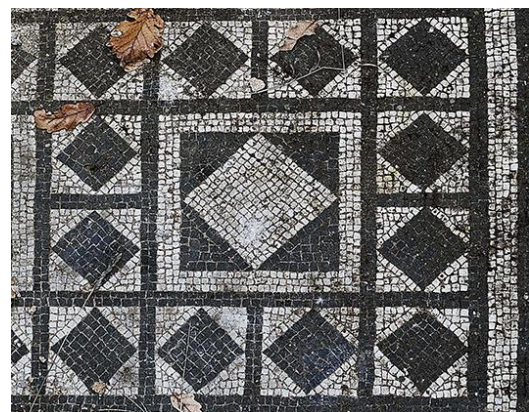
Figure 18. Basic element of the mosaic floor

Similarly, an orthoplan can be generated in the pavement plane (x,z). For the reconstruction of the mosaic floor of the nymphaeum, a photogrammetric shoot was taken; subsequently the creation of an orthoplan allowed for the reconstruction by the symmetry of the entire floor.

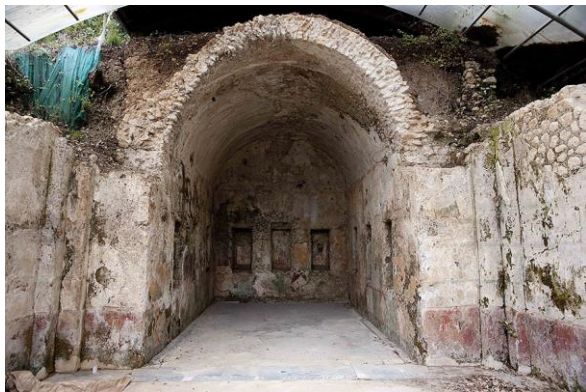
Figure 21. Panoramic fusion of 3 shoots

A global assessment of the degradation conditions of the entire nymphaeum was obtained by a panoramic fusion operation of three single images (Fig.21) through the reading of the camera's metadata (focal length, values and type of optical distortions), thus obtaining an image in which the evolution of the degradation is evident.
