DIGITAL RECORDING AND NON-DESTRUCTIVE TECHNIQUES FOR THE UNDERSTANDING OF STRUCTURAL PERFORMANCE FOR REHABILITATING HISTORIC STRUCTURES AT THE KATHMANDU VALLEY AFTER GORKHA EARTHQUAKE 2015

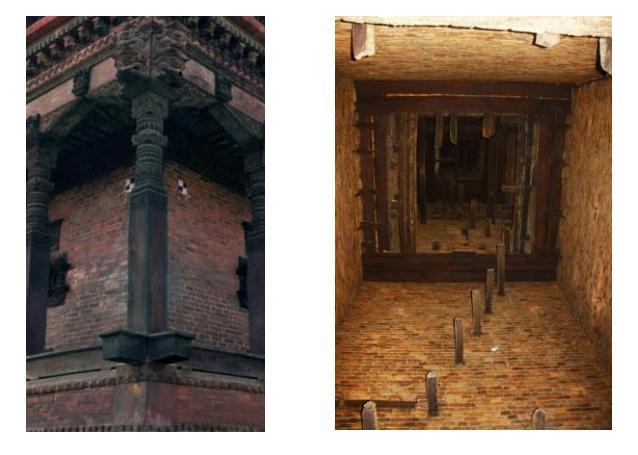
Figure 9. Detail of Column post (left) and ceiling view of inside from first-floor level (right)

The ground floor plan is symmetrical with a perimeter wall of approximately 1.45m thick and colonnade area. The main wall is constructed with brickwork and mud mortar, with a door on each side. The colonnade roof is supported by six wooden timber post on each side. Timber posts in the colonnade are braced with horizontal beams in the base level and floor level. There is a stone block below each column post. The timber floor of the colonnade is elevated above a void to encourage evaporation and prevent the wood from decay and damp. (Figure 9, 10)

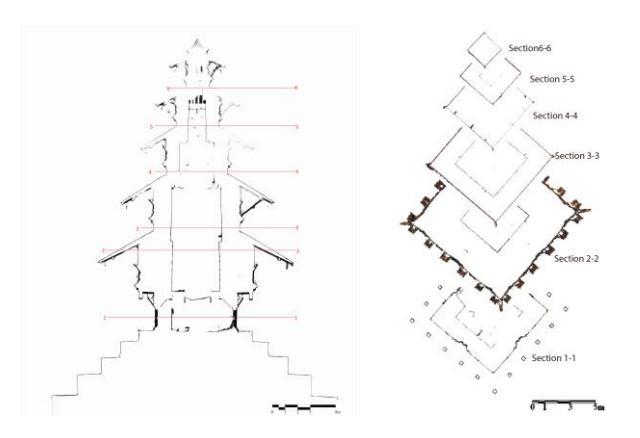
Figure 10. Schematic representation E-W section of Nyatapola temple and the floor plans generated from the point cloud

The main walls extend up to the second floor; in the first floor there exists another external wall just above the column post of collonade. After the first floor, the interior of the temple is open (there are no floors), hence it is difficult to reach the upper levels of the structure and they were not directly scanned. (Figure 9, 10) The walls are connected to timber beams at different levels by wooden nails. As the temple superstructure extends upward, the plan area is gradually reduced. This is accomplished by constructing the walls of each level on an axis which is offset inwards from the level below, i.e., the outer edge of the upper wall is aligned roughly with the center of the wall below. The walls of each level were constructed just above timber beams.
